Carburetor Icing as a Source of Flight Safety Hazards

Abstract

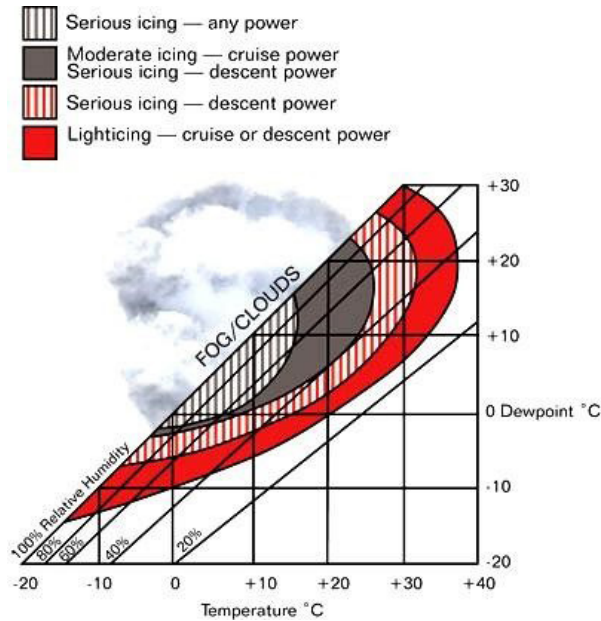
Figure 1. Graph of the probability of carburetor icing occurring. Adopted from: “An Icing Of Aircraft – Reasons, Consequences, Counteraction,” by Gębura et al. Copyright 2014 by *Journal of KONBiN*.

In the case of moderate icing, this time is extended and ranges from 0.5 to 1 mm/min. Heavy icing occurs at a rate of 1 to 2 mm/min. However, very heavy icing indicates the formation of ice at a rate above 2 mm/min. General carburetor icing is related to the formation of ice in the carburetor throat, on the throttle or in the bends of the intake system. This results in the throttle being blocked due to the accumulation of large amounts of ice or blockage of the nozzles and intake pipes. A graph illustrating the probability of icing is shown in figure (Figure 1).
